## Test Report

No.: CKGEC24000037929

Sample Name: Optic glass

Model No.: H-ZK11

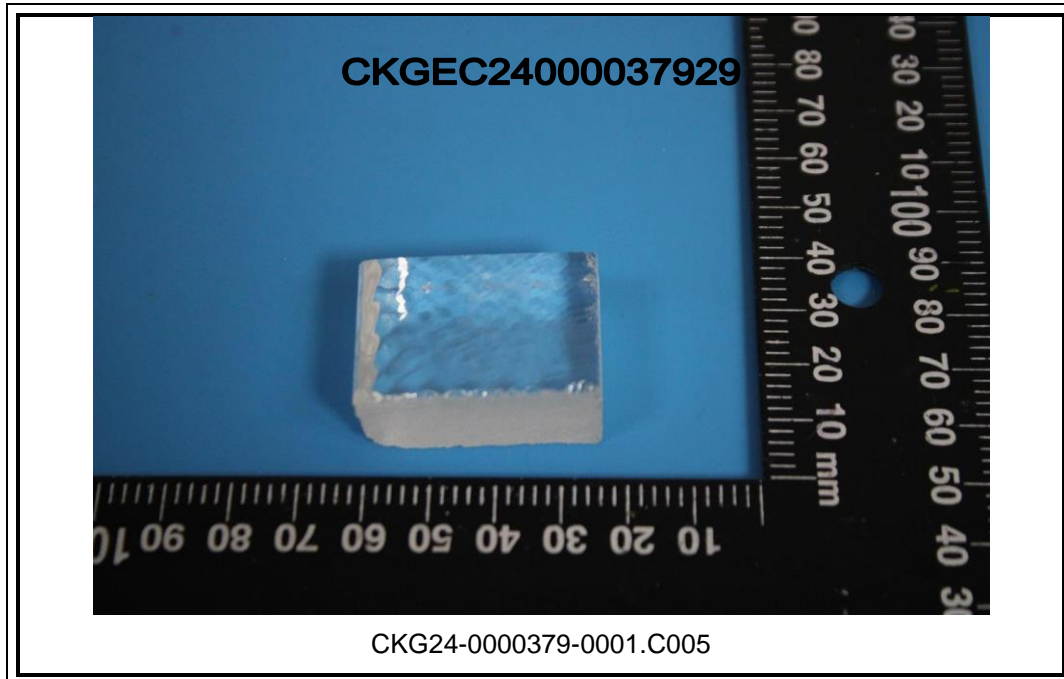
Sample Photo:

SN ID	Sample No.	SGS Sample ID	Description
SN1	A5	CKG24-0000379-0001.C005	Colorless transparent glass
