Test Report

No. CKGEC2300888965

Sample Name : Optic glass

Model No. : QB76

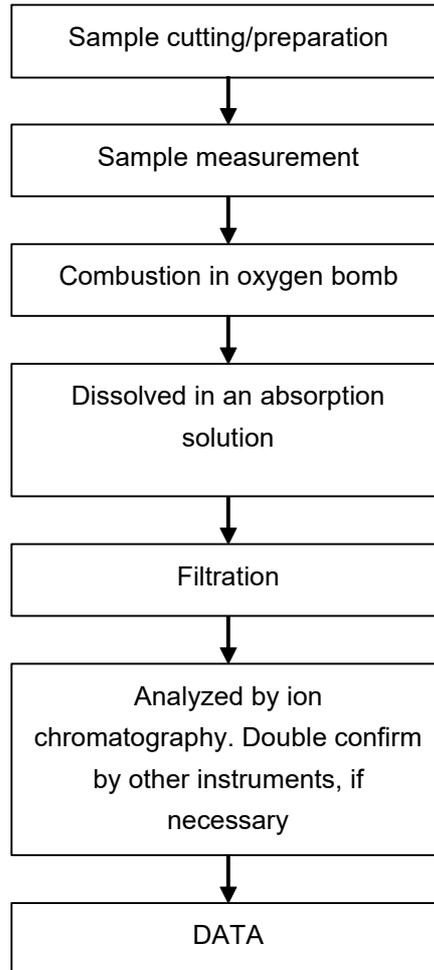
Halogen and Sulfur Testing (oxygen bomb) Flow Chart

Test Method : With reference to EN 14582: 2016, analysis was performed by Ion Chromatograph (IC).

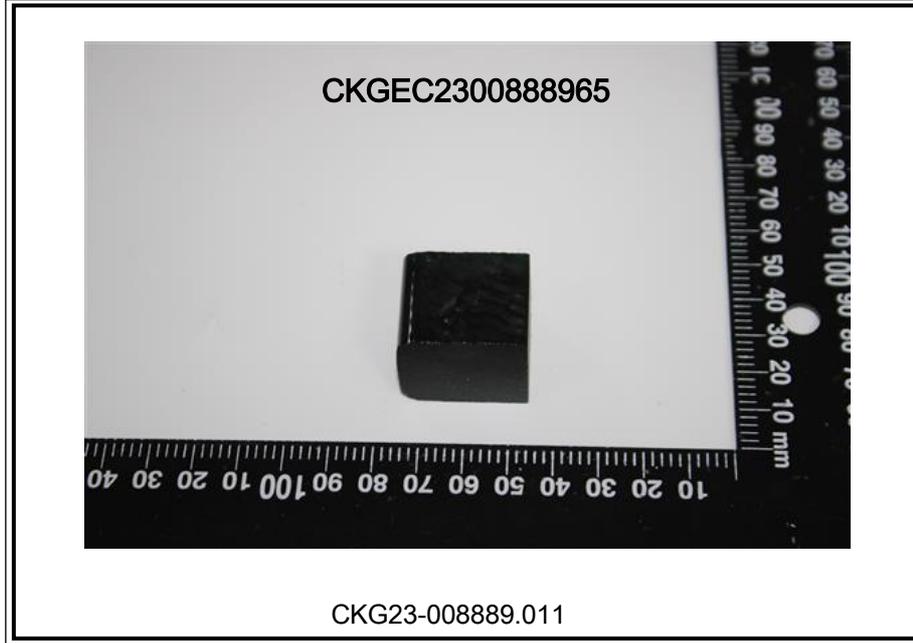
Sample photo:

Specimen No.	SGS Sample ID	Description
SN1	CKG23-008889.011	Green glass
