Test Report

No. CKGEC2300337621

Sample Name : Optic glass

Model No. : D-ZLaF61

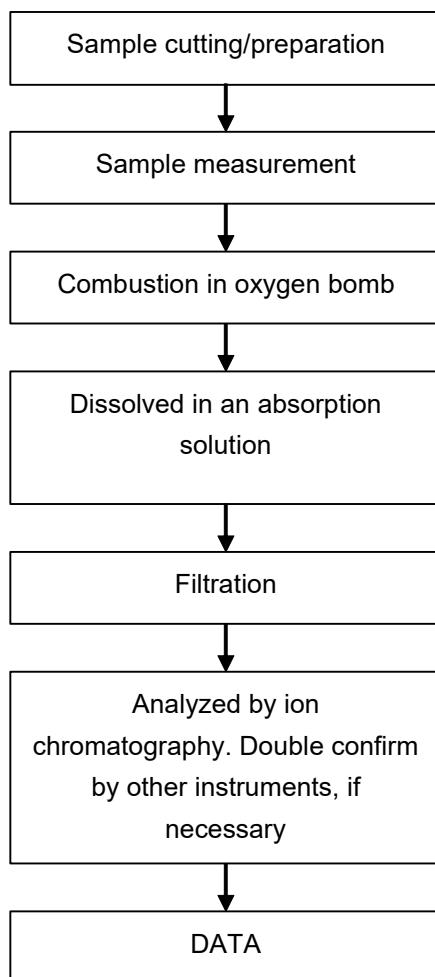
Halogen and Sulfur Testing (oxygen bomb) Flow Chart

Test Method : With reference to EN 14582: 2016, analysis was performed by Ion Chromatograph (IC).

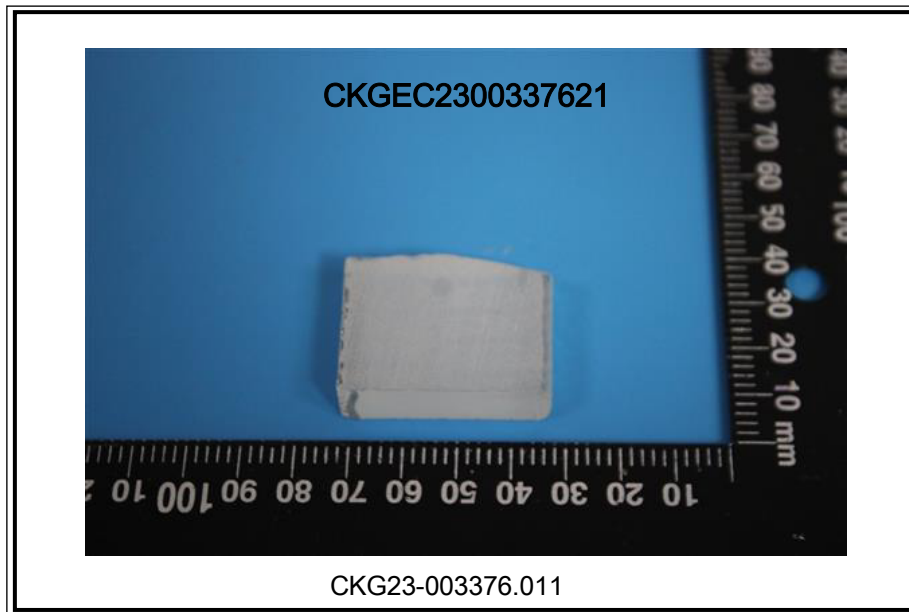
Sample photo:

Specimen No.	SGS Sample ID	Description
SN1	CKG23-003376.011	Colorless translucent glass
