Test Report

No. CKGEC2300337613

Sample Name : Optic glass

Model No. : H-ZLaF68C

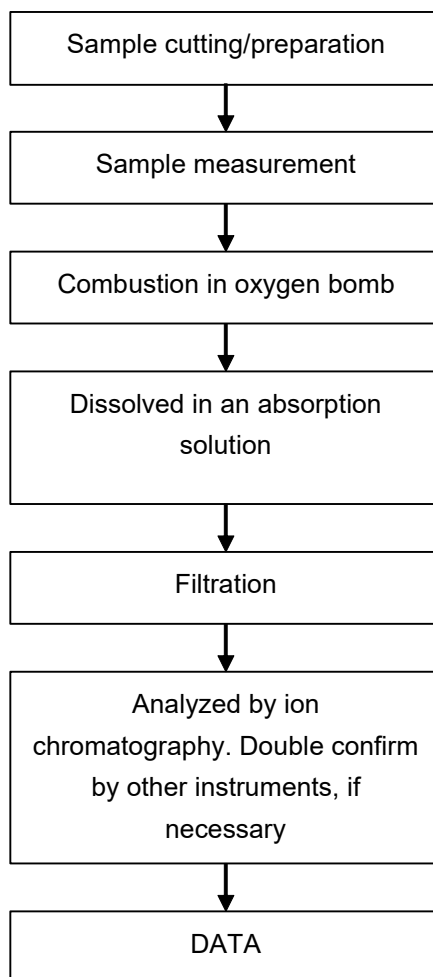
Halogen and Sulfur Testing (oxygen bomb) Flow Chart

Test Method : With reference to EN 14582: 2016, analysis was performed by Ion Chromatograph (IC).

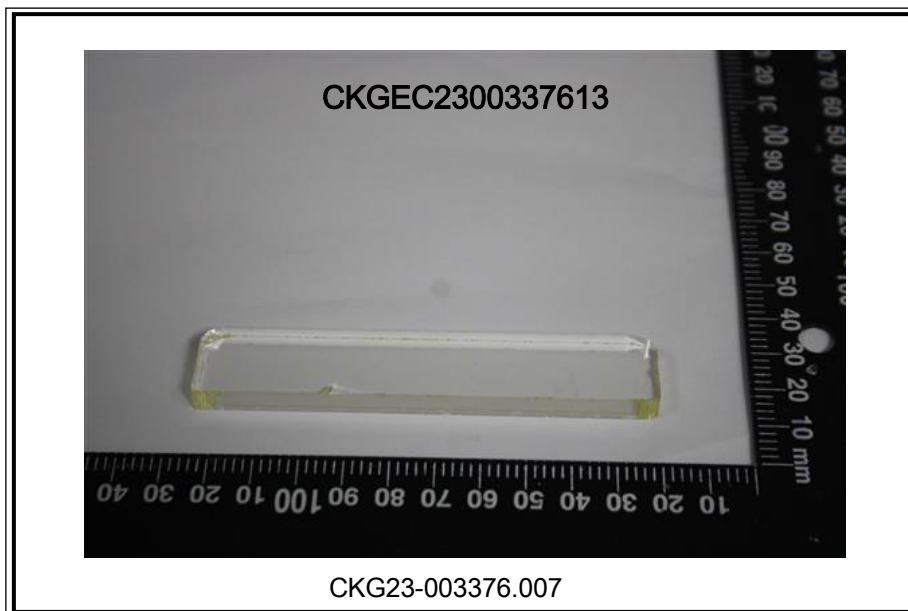
Sample photo:

Specimen No.	SGS Sample ID	Description
SN1	CKG23-003376.007	Light yellow glass
