Test Report

No. CKGEC2300337649

Sample Name : Optic glass

Model No. : D-LaF50

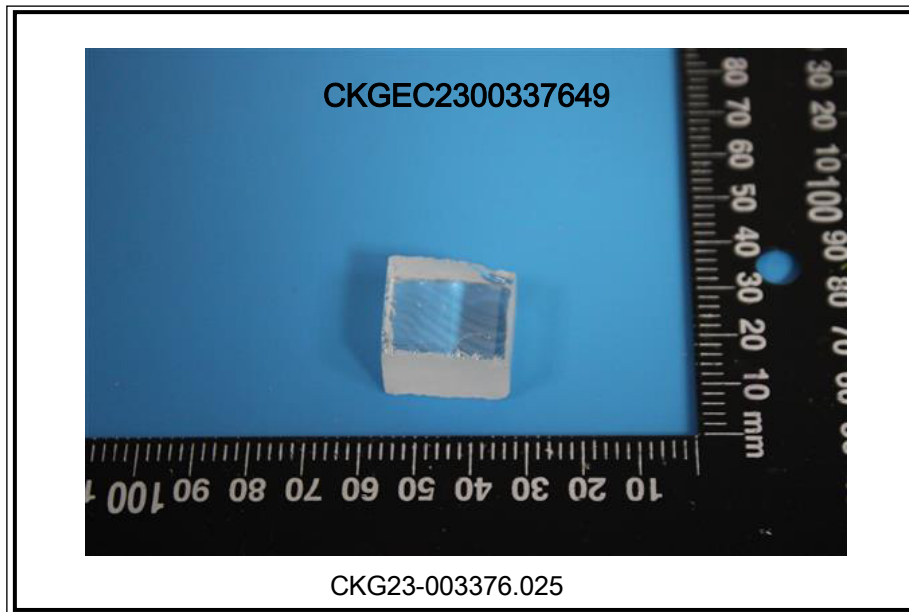
Sample photo:

Specimen No.	SGS Sample ID	Description
SN1	CKG23-003376.025	Colorless transparent glass
