## Test Report

No. CKGEC2300492219

Sample Name : Optic glass

Model No. : H-ZF71GT

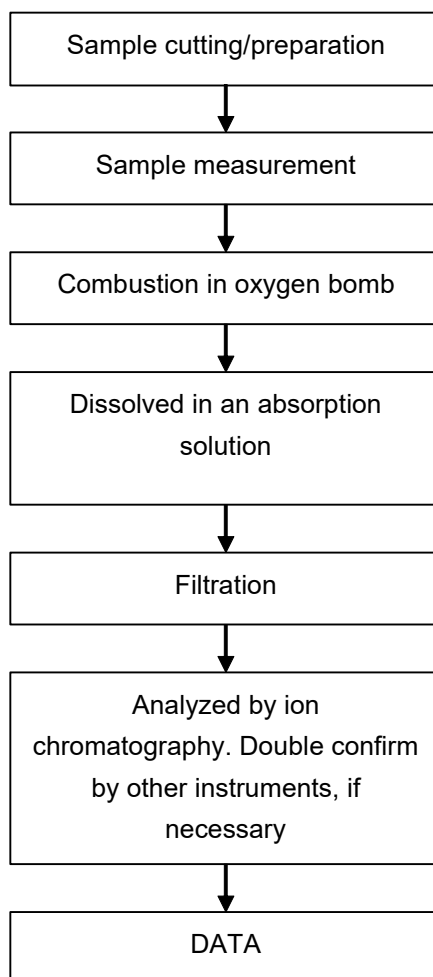
### Halogen and Sulfur Testing (oxygen bomb) Flow Chart

Test Method : With reference to EN 14582: 2016, analysis was performed by Ion Chromatograph (IC).

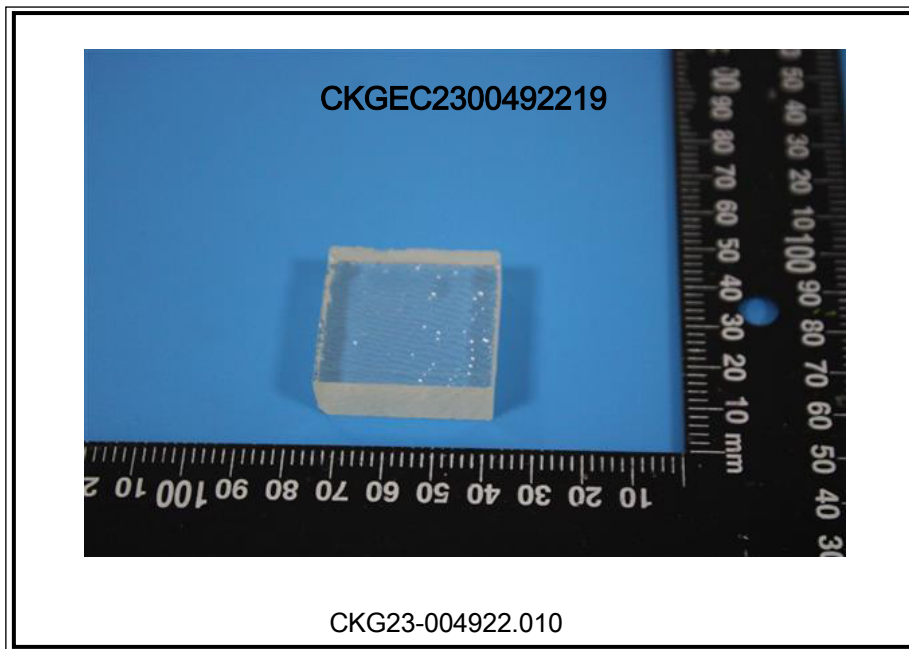
Sample photo:

Specimen No.	SGS Sample ID	Description
SN1	CKG23-004922.010	Colorless transparent glass
