Test Report

No. CKGEC2300492217

Sample Name : Optic glass

Model No. : H-ZLAF69A

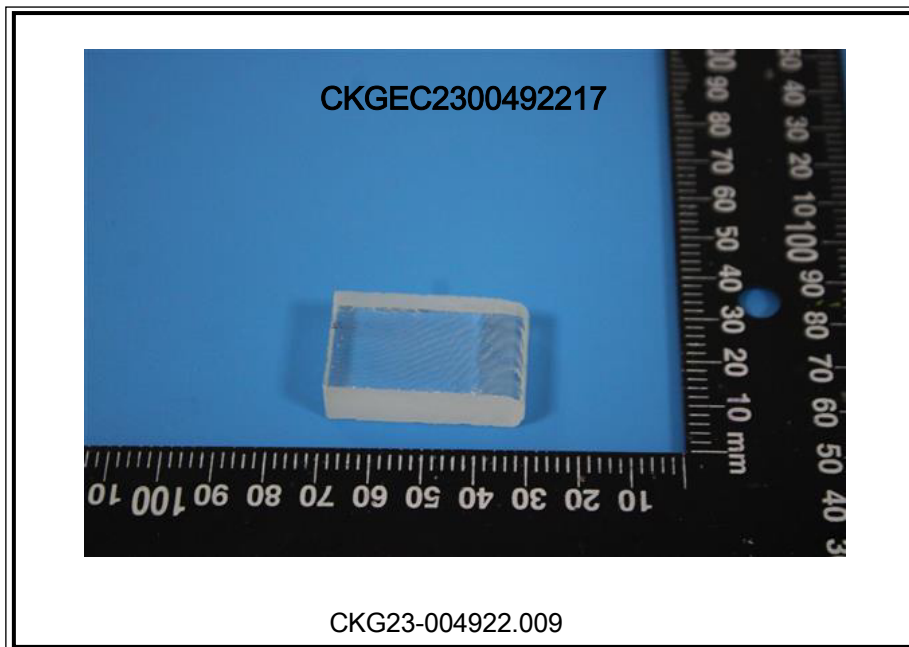
Sample photo:

Specimen No.	SGS Sample ID	Description
SN1	CKG23-004922.009	Colorless transparent glass
