Test Report

No. CKGEC2300492215

Sample Name : Optic glass

Model No. : H-QF6

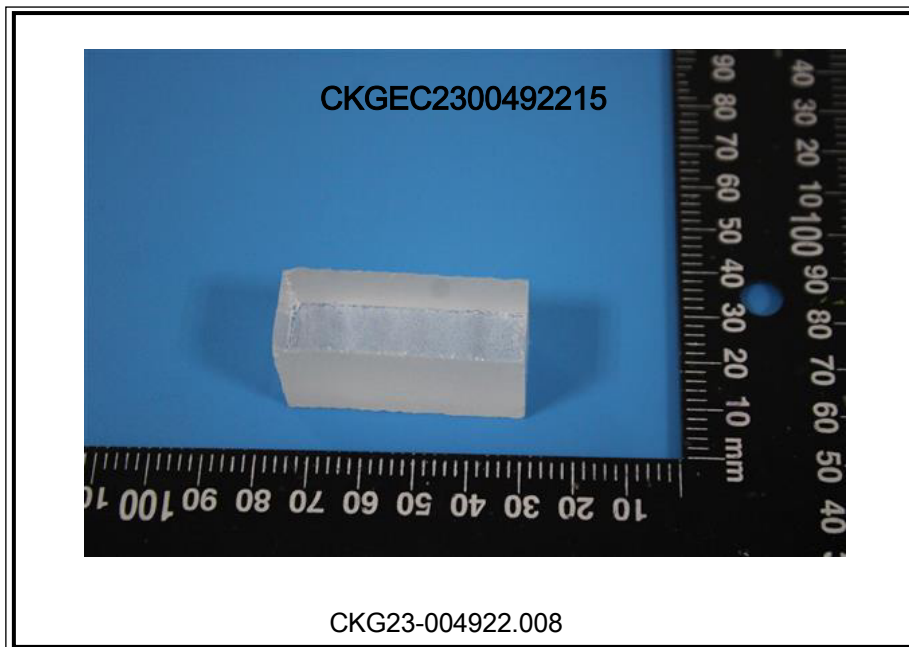
Sample photo:

Specimen No.	SGS Sample ID	Description
SN1	CKG23-004922.008	Colorless translucent glass
