Test Report

No. CKGEC2300490441

Sample Name : Optic glass

Model No. : D-ZK2L

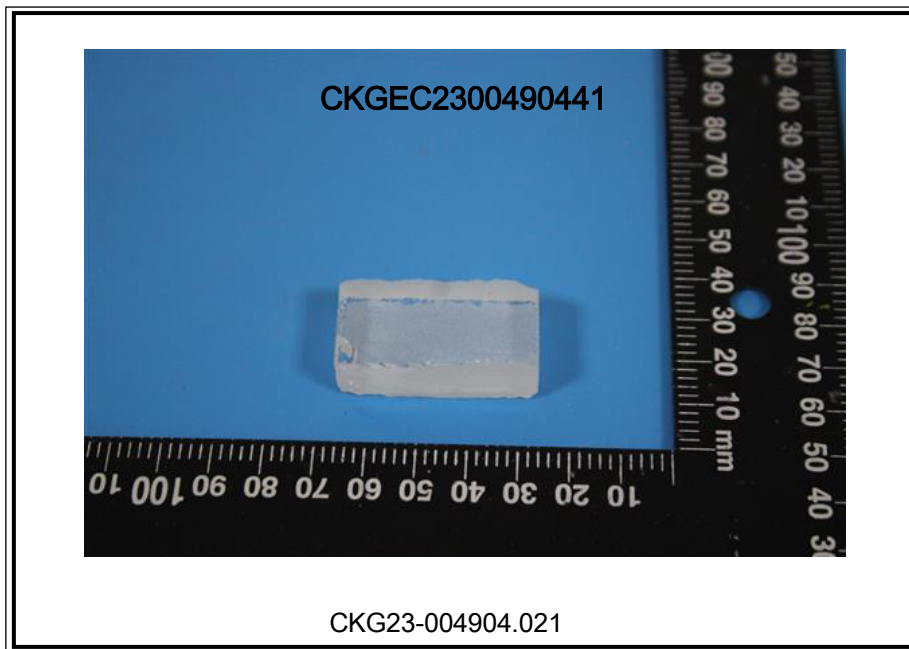
Sample photo:

Specimen No.	SGS Sample ID	Description
SN1	CKG23-004904.021	Colorless transparent glass
