Test Report

No. CKGEC2300793221

Sample Name : Optic glass

Model No. : H-ZLAF89L

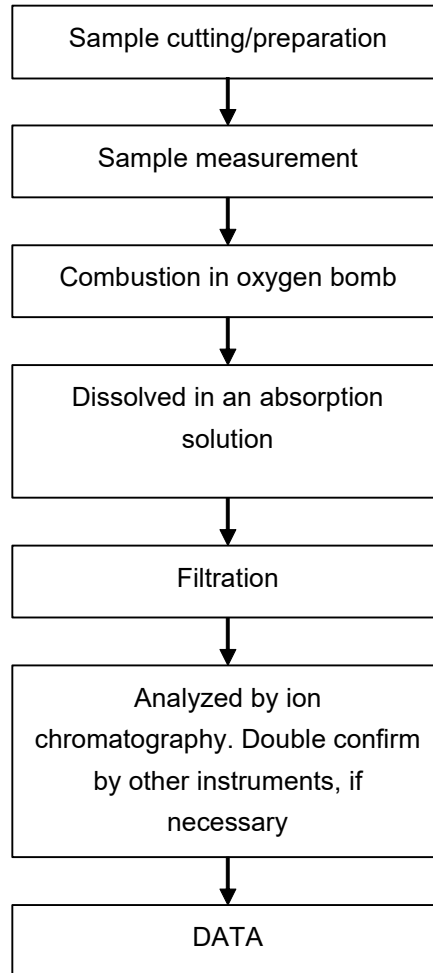
Halogen and Sulfur Testing (oxygen bomb) Flow Chart

Test Method : With reference to EN 14582: 2016, analysis was performed by Ion Chromatograph (IC).

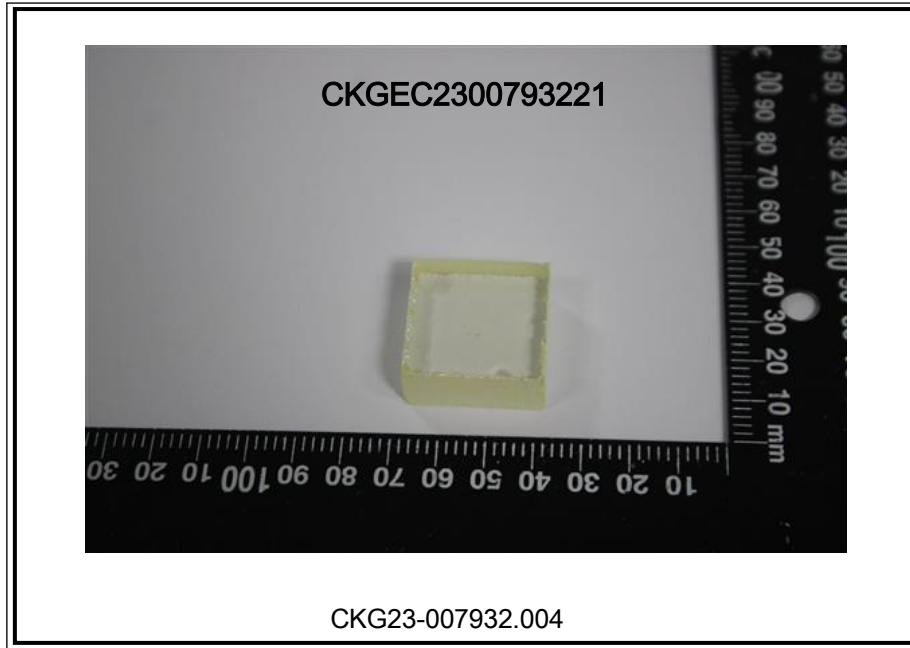
Sample photo:

Specimen No.	SGS Sample ID	Description
SN1	CKG23-007932.004	Yellow glass
