## Test Report

No. CKGEC2300991811

Sample Name : Optic glass

Model No. : QB55

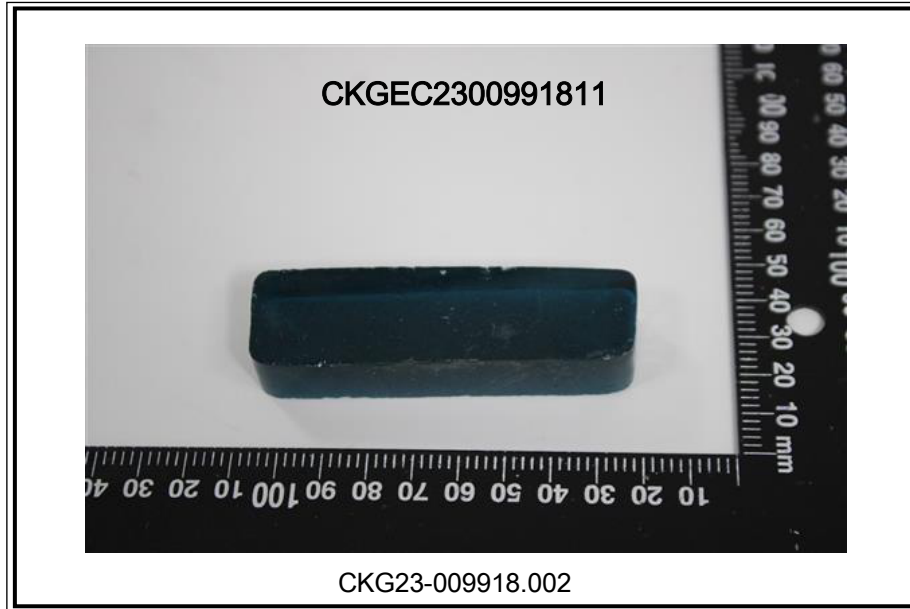
Sample photo:

Specimen No.	SGS Sample ID	Description
SN1	CKG23-009918.002	Blue glass
