## Test Report

No.: CKGEC24000191229

Sample Name: Optic glass

Model No.: H-TF3L

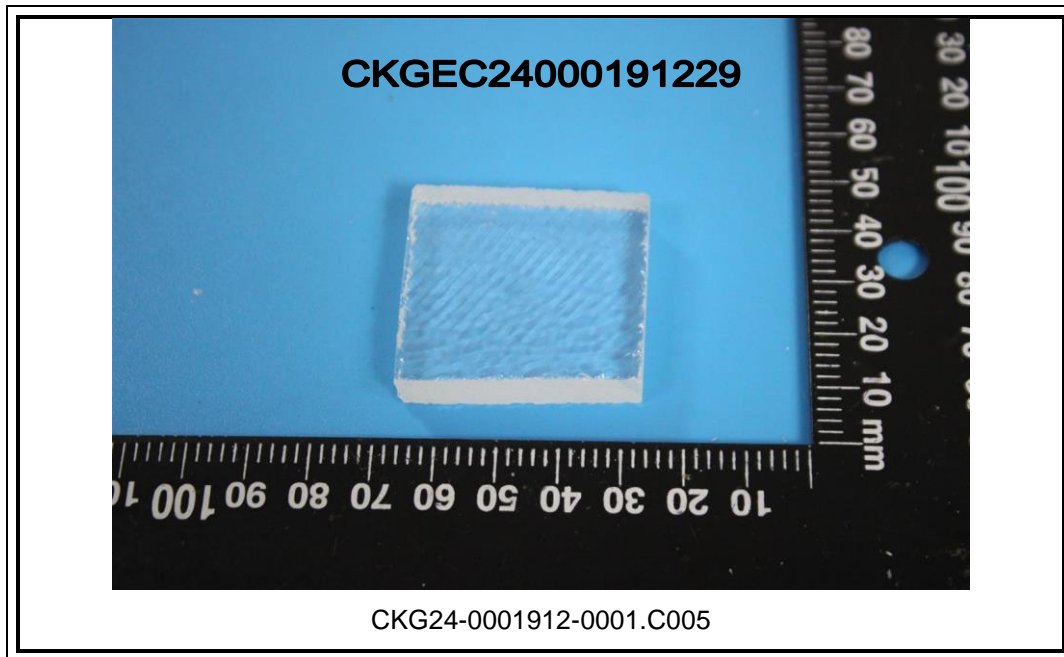
Sample Photo:

SN ID	Sample No.	SGS Sample ID	Description
SN1	A5	CKG24-0001912-0001.C005	Colorless transparent glass
