Test Report

No. CKGEC2300888925

Sample Name : Optic glass

Model No. : H-ZLAF53BGT

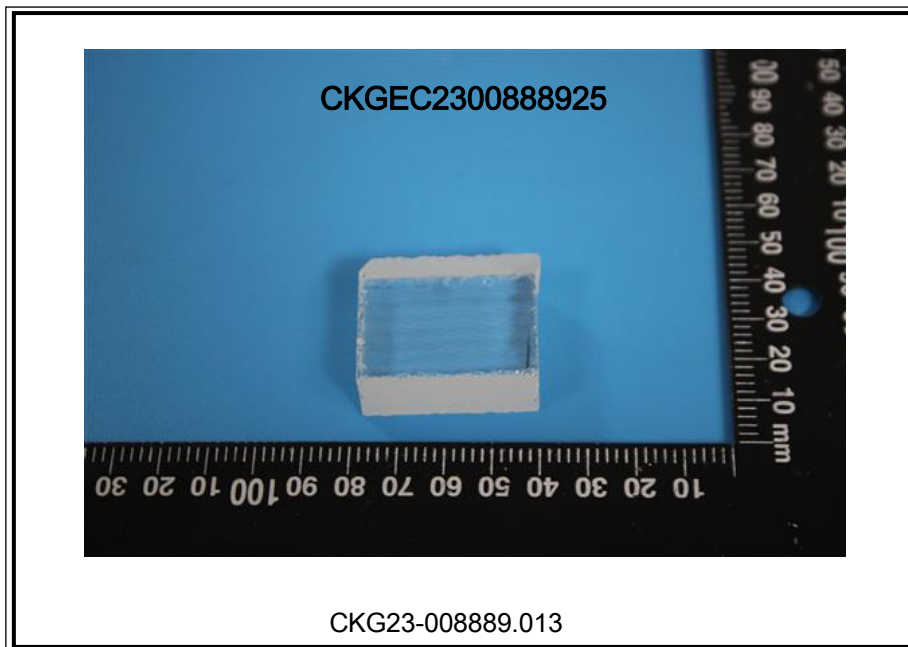
Sample photo:

Specimen No.	SGS Sample ID	Description
SN1	CKG23-008889.013	Colorless transparent glass
