## Test Report

No.: CKGEC24000037947

Sample Name: Optic glass

Model No.: H-QF1

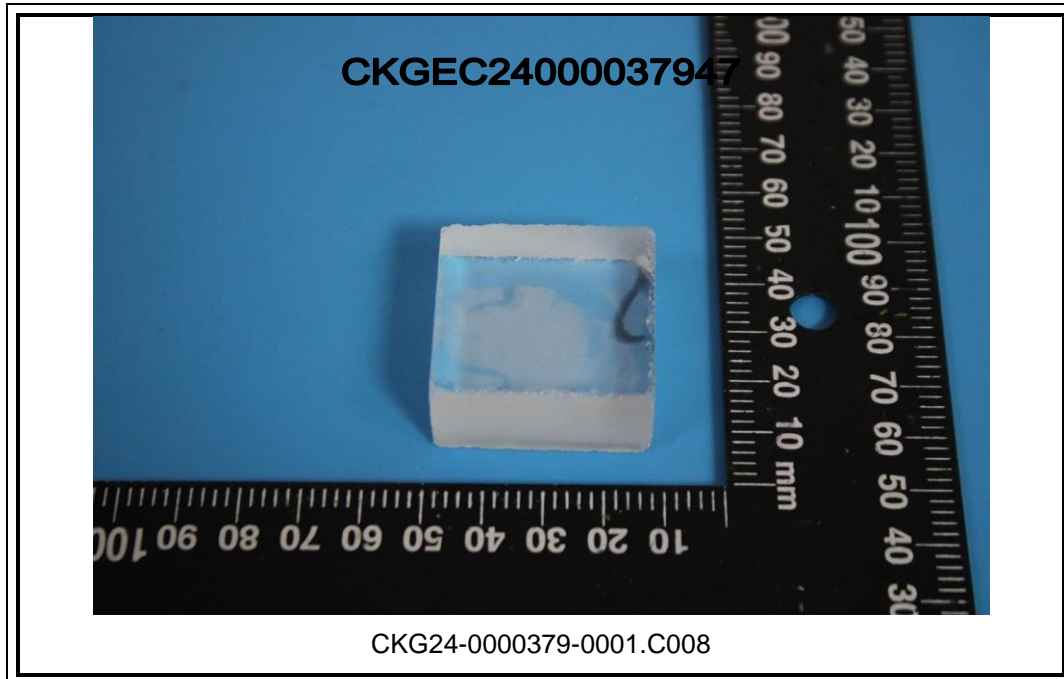
Sample Photo:

SN ID	Sample No.	SGS Sample ID	Description
SN1	A8	CKG24-0000379-0001.C008	Colorless semi transparent glass
