Test Report

No. CKGEC2301072749

Sample Name : Optic glass

Model No. : H-ZF13GT

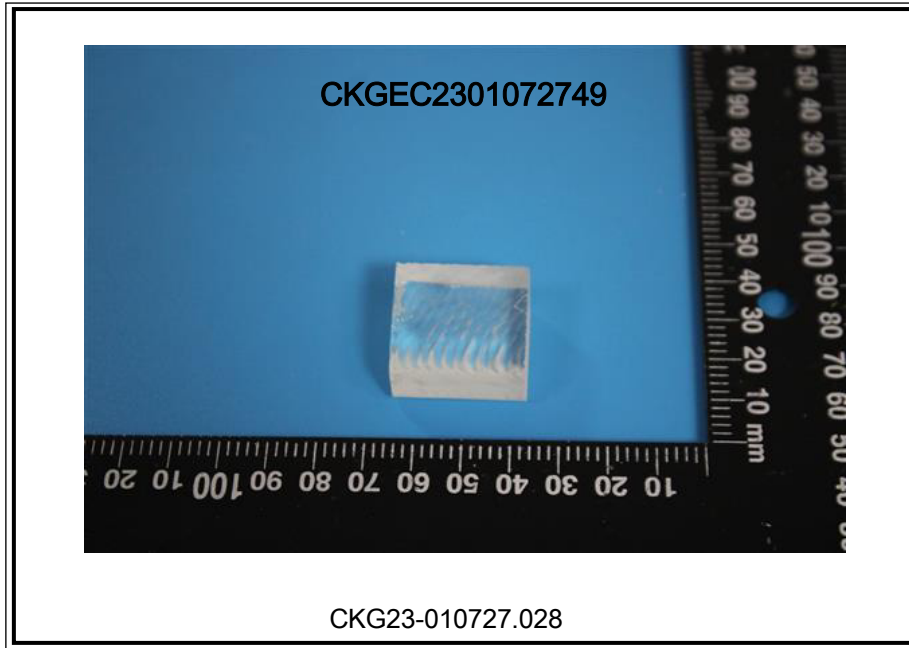
Sample photo:

Specimen No.	SGS Sample ID	Description
SN1	CKG23-010727.028	Colorless transparent glass
