Test Report

No.: CKGEC24000037935

Sample Name: Optic glass

Model No.: H-ZK14

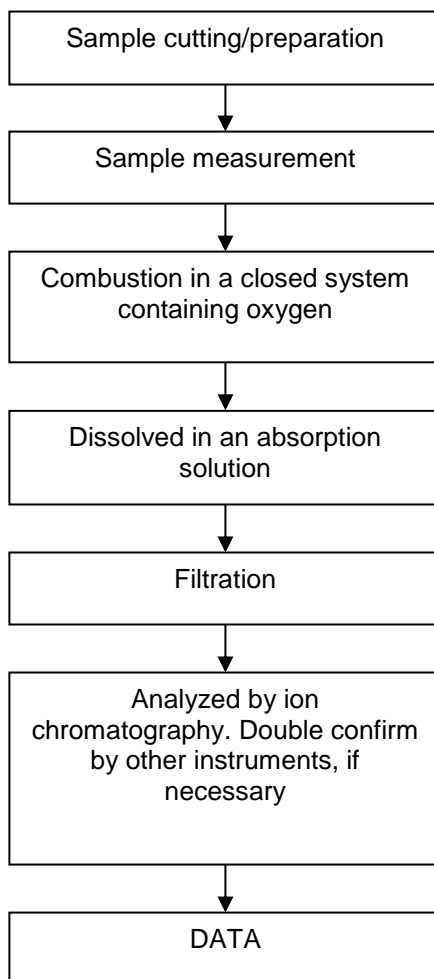
Halogen Testing Flow Chart

Test Method: With reference to EN 14582:2016, analysis was performed by IC.

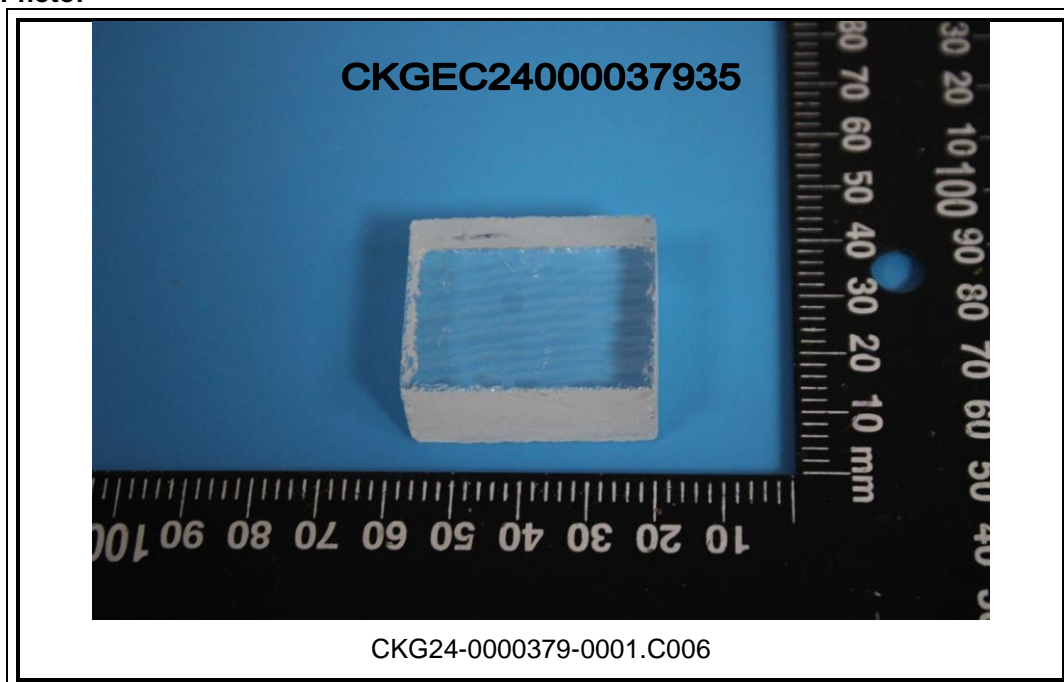
Sample Photo:

SN ID	Sample No.	SGS Sample ID	Description
SN1	A6	CKG24-0000379-0001.C006	Colorless transparent glass
