Test Report

No.: CKGEC24000040943

Sample Name: Optic glass

Model No.: H-ZF62

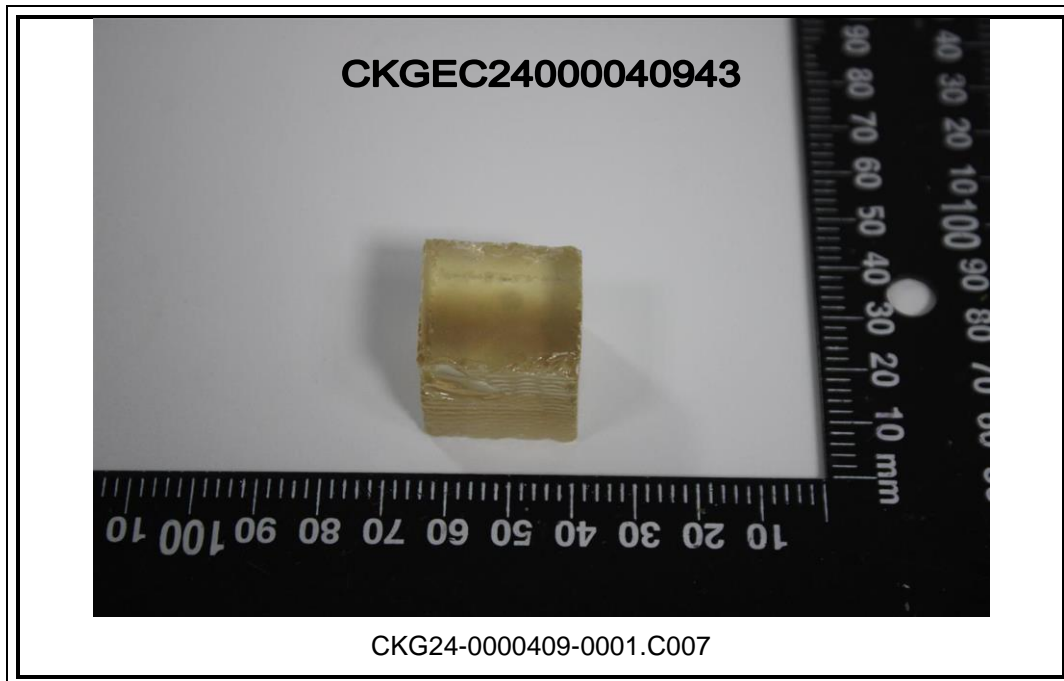
Sample Photo:

SN ID	Sample No.	SGS Sample ID	Description
SN1	A7	CKG24-0000409-0001.C007	Yellow semi transparent glass
