Test Report

No. CKGEC2300792903

Sample Name : Optic glass

Model No. : H-FK61

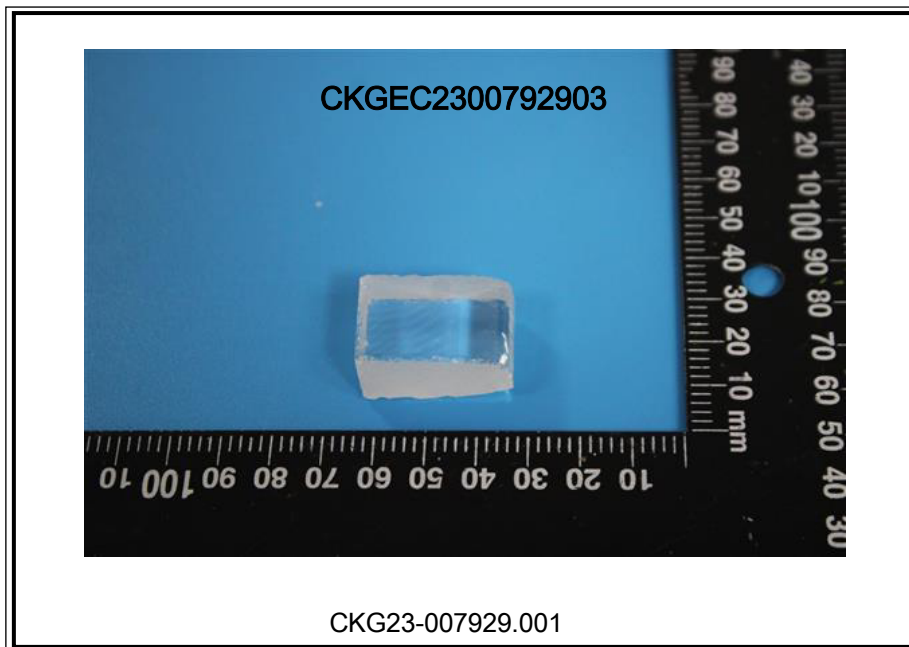
Sample photo:

Specimen No.	SGS Sample ID	Description
SN1	CKG23-007929.001	Colorless transparent glass
