Test Report

No.: CKGEC24000191235

Sample Name: Optic glass

Model No.: D-ZLaF67

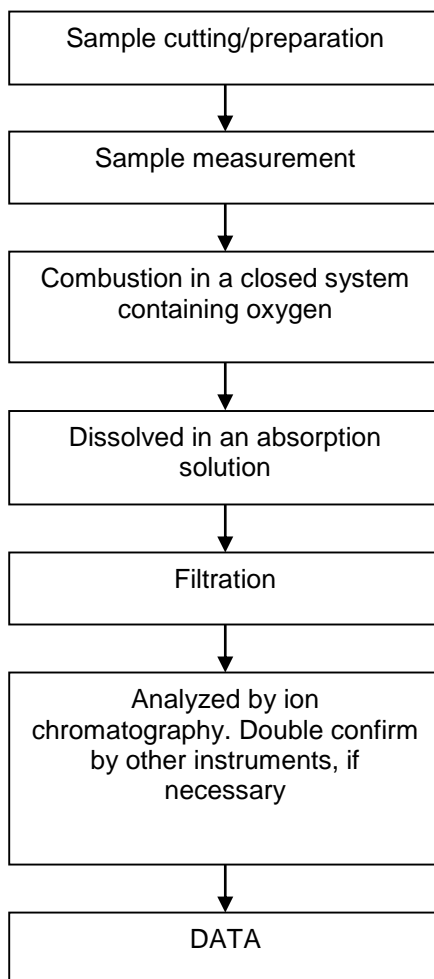
Halogen Testing Flow Chart

Test Method: With reference to EN 14582:2016, analysis was performed by IC.

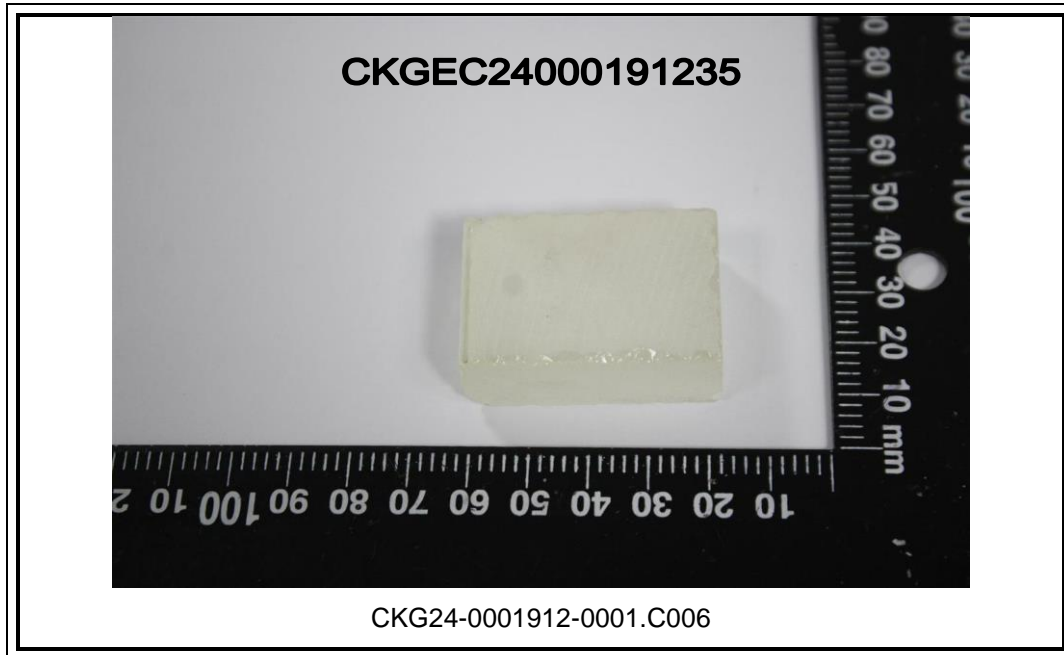
Sample Photo:

SN ID	Sample No.	SGS Sample ID	Description
SN1	A6	CKG24-0001912-0001.C006	Light yellow semi transparent glass
