Test Report

No. CKGEC2300888937

Sample Name : Optic glass

Model No. : D-K9GT

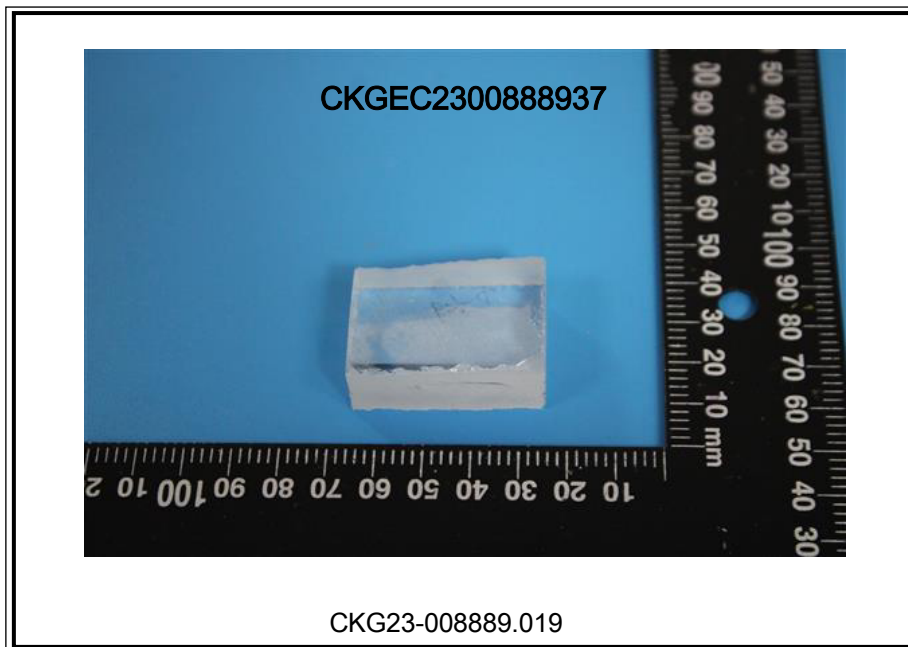
Sample photo:

Specimen No.	SGS Sample ID	Description
SN1	CKG23-008889.019	Colorless transparent glass
