Test Report

No.: CKGEC24000039817

Sample Name: Optic glass

Model No.: H-ZF71

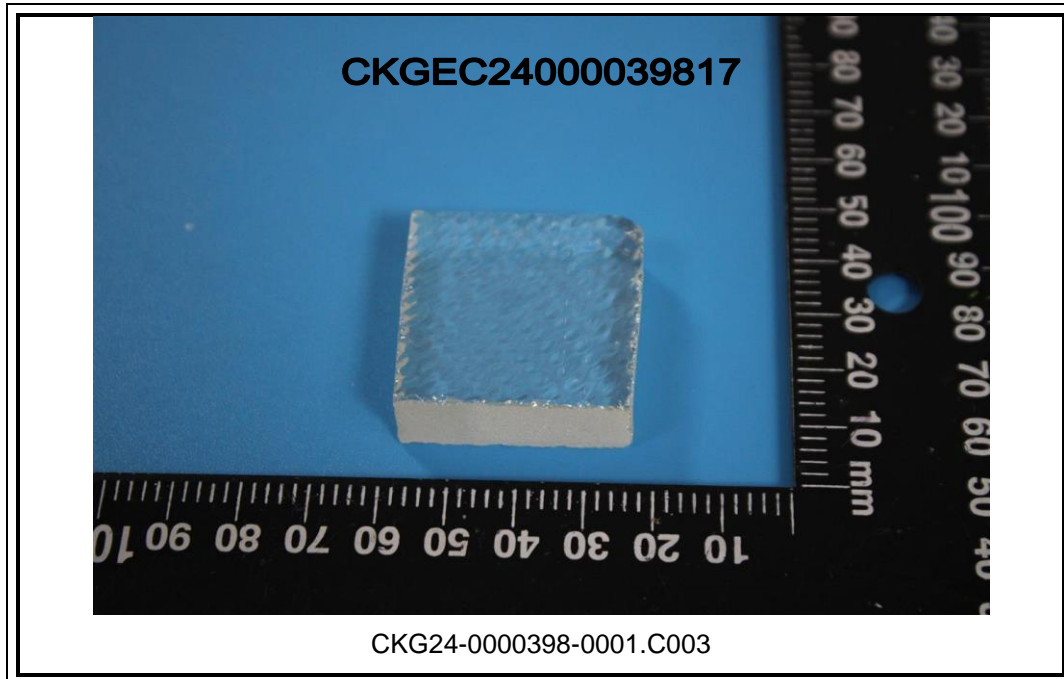
Sample Photo:

SN ID	Sample No.	SGS Sample ID	Description
SN1	A3	CKG24-0000398-0001.C003	Colorless semi transparent glass
