Test Report

No. CKGEC2300793415

Sample Name : Optic glass

Model No. : H-ZF62GT

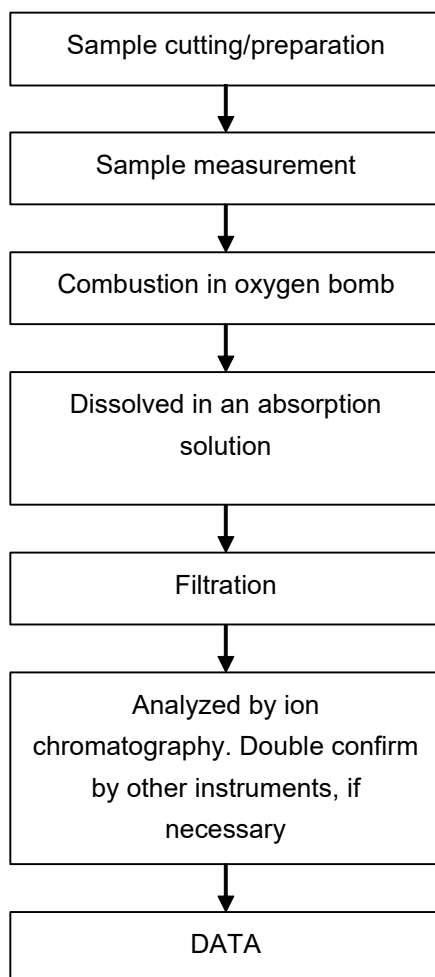
Halogen and Sulfur Testing (oxygen bomb) Flow Chart

Test Method : With reference to EN 14582: 2016, analysis was performed by Ion Chromatograph (IC).

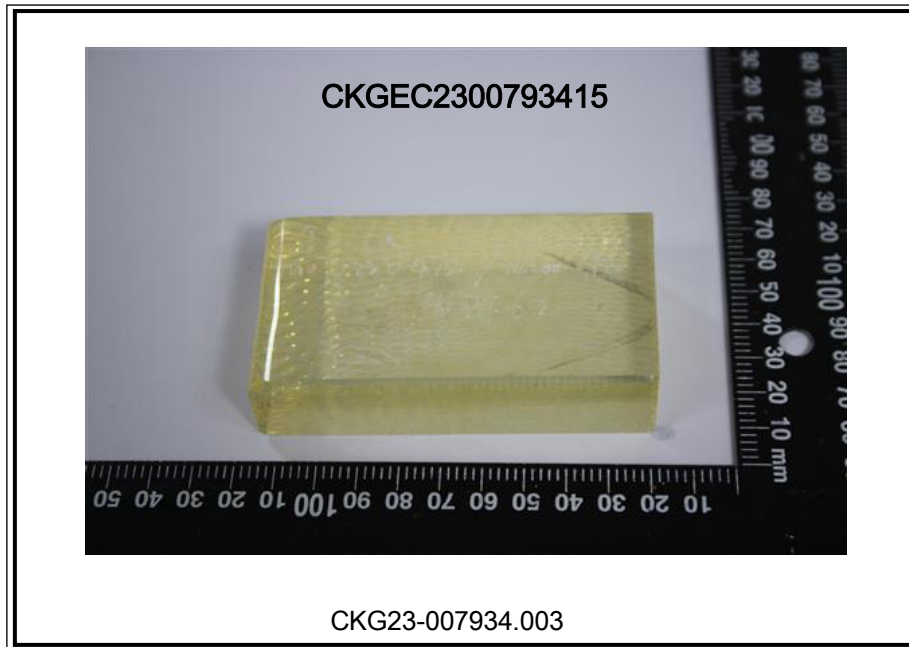
Sample photo:

Specimen No.	SGS Sample ID	Description
SN1	CKG23-007934.003	Yellow glass
