Test Report

No. CKGEC2300793239

Sample Name : Optic glass

Model No. : D-LAF53

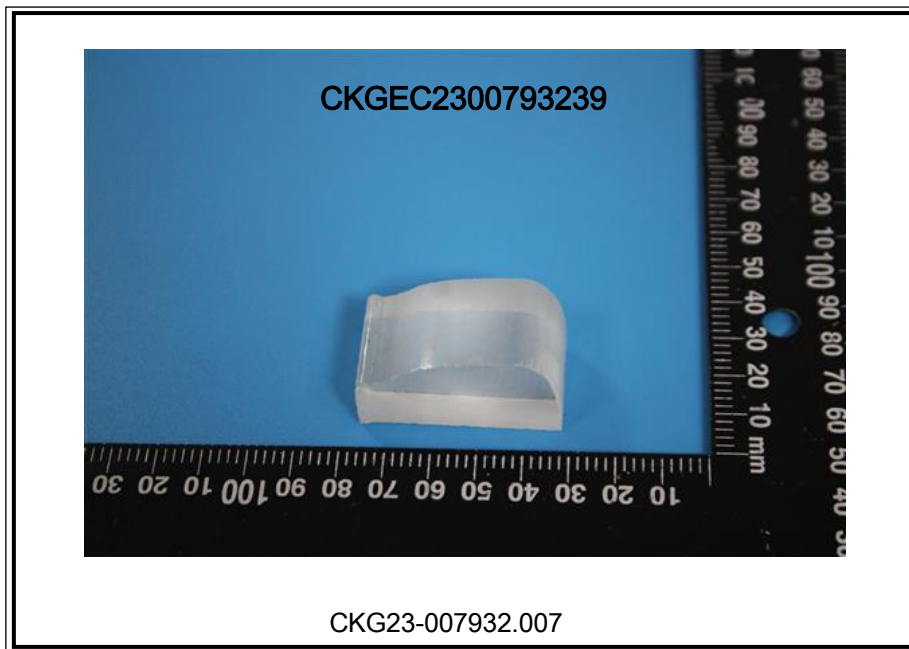
Sample photo:

Specimen No.	SGS Sample ID	Description
SN1	CKG23-007932.007	Colorless transparent glass
