Test Report

No. CKGEC2301072747

Sample Name : Optic glass

Model No. : D-K59

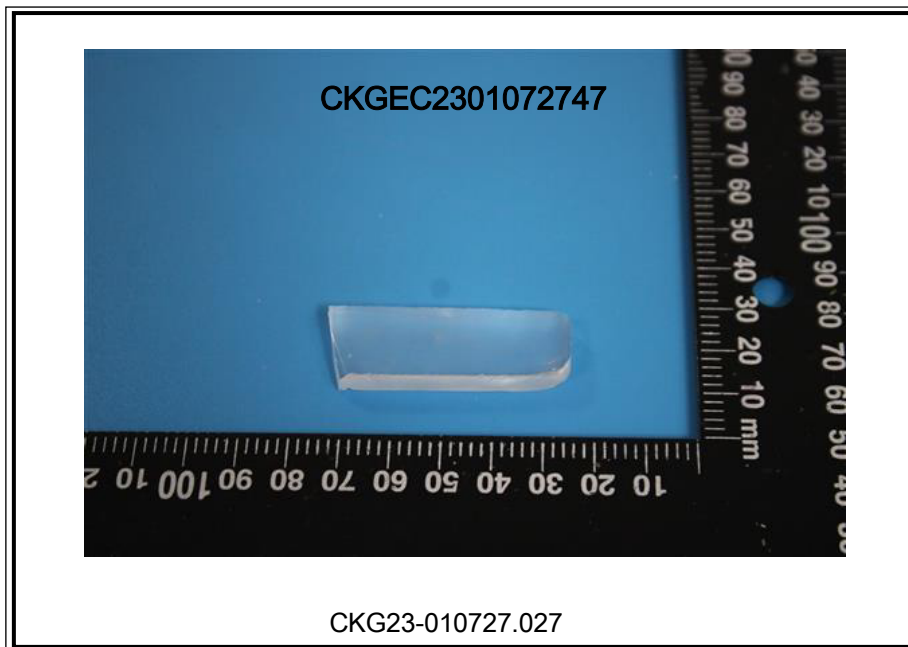
Sample photo:

Specimen No.	SGS Sample ID	Description
SN1	CKG23-010727.027	Colorless transparent glass
