## Test Report

No.: CKGEC24000039811

Sample Name: Optic glass

Model No.: H-ZBAF52

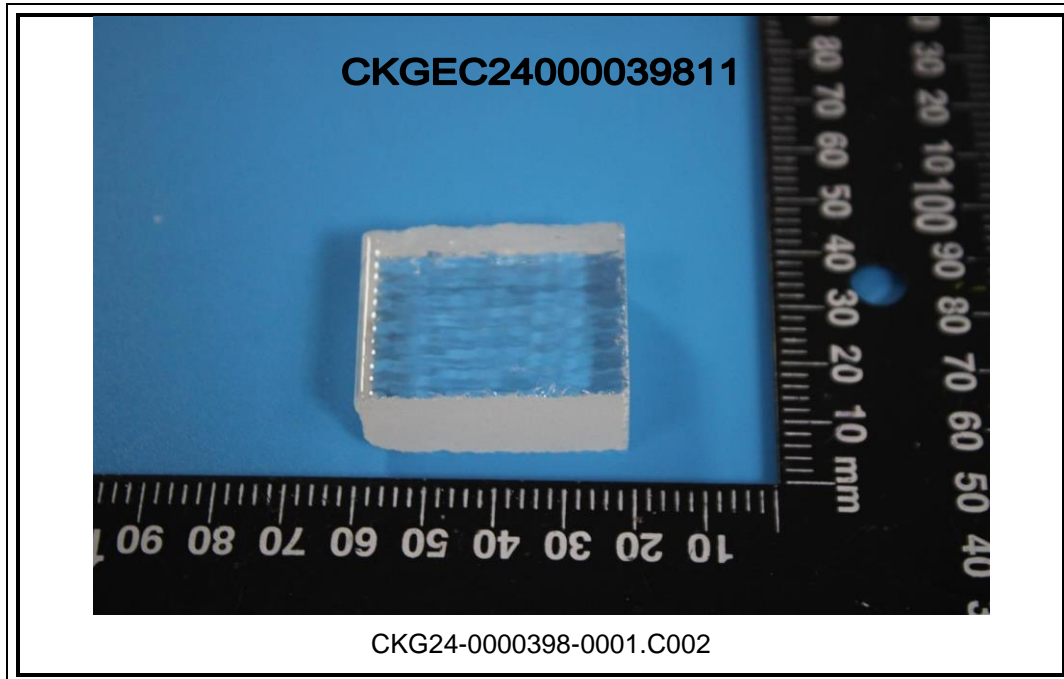
Sample Photo:

SN ID	Sample No.	SGS Sample ID	Description
SN1	A2	CKG24-0000398-0001.C002	Colorless transparent glass
