Test Report

No. CKGEC2301072753

Sample Name : Optic glass

Model No. : H-ZK3A

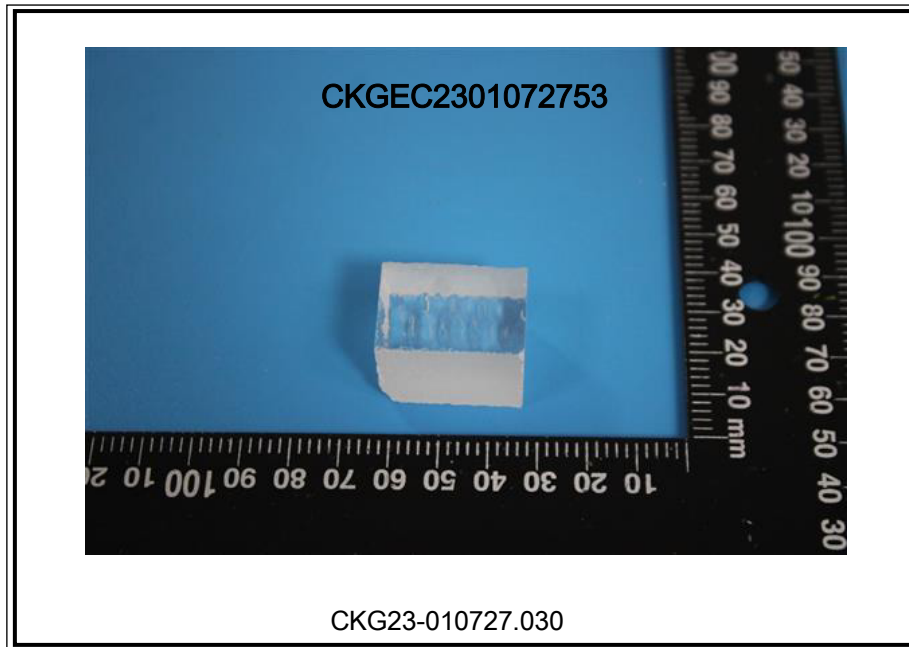
Sample photo:

Specimen No.	SGS Sample ID	Description
SN1	CKG23-010727.030	Colorless transparent glass
