Test Report

No.: CKGEC24000190361

Sample Name: Optic glass

Model No.: D-ZLAF52C

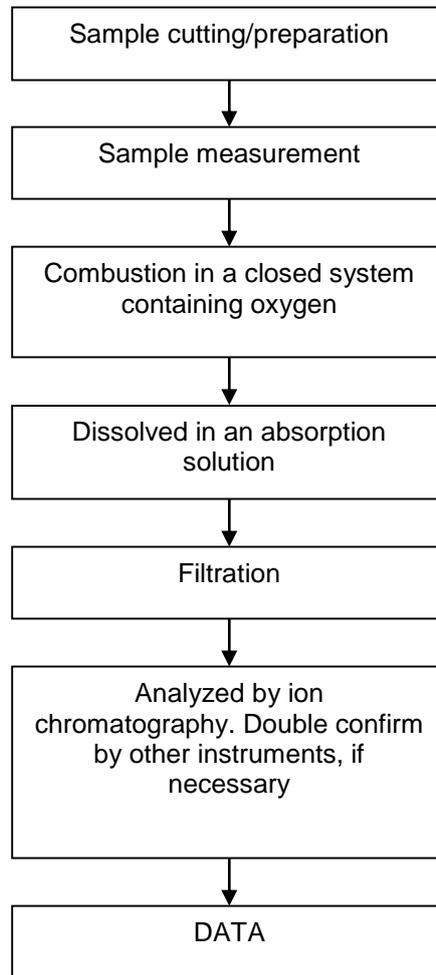
Halogen Testing Flow Chart

Test Method: With reference to EN 14582:2016, analysis was performed by IC.

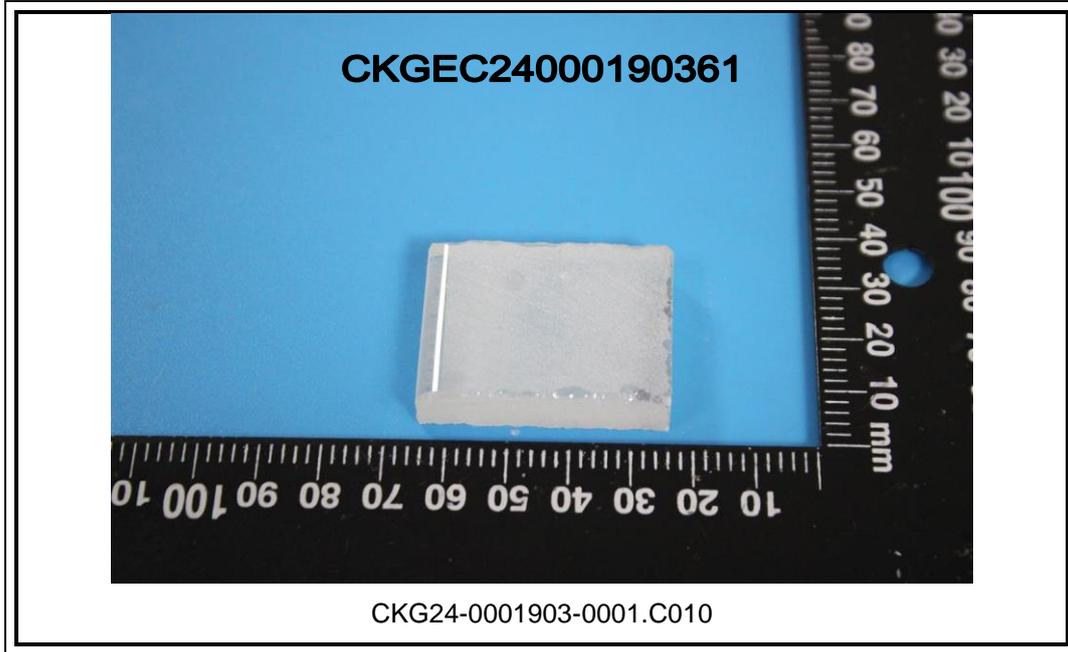
Sample Photo:

SN ID	Sample No.	SGS Sample ID	Description
SN1	A10	CKG24-0001903-0001.C010	Colorless semi transparent glass
