Test Report

No. CKGEC2301072329

Sample Name : Optic glass

Model No. : D-ZLAF52A

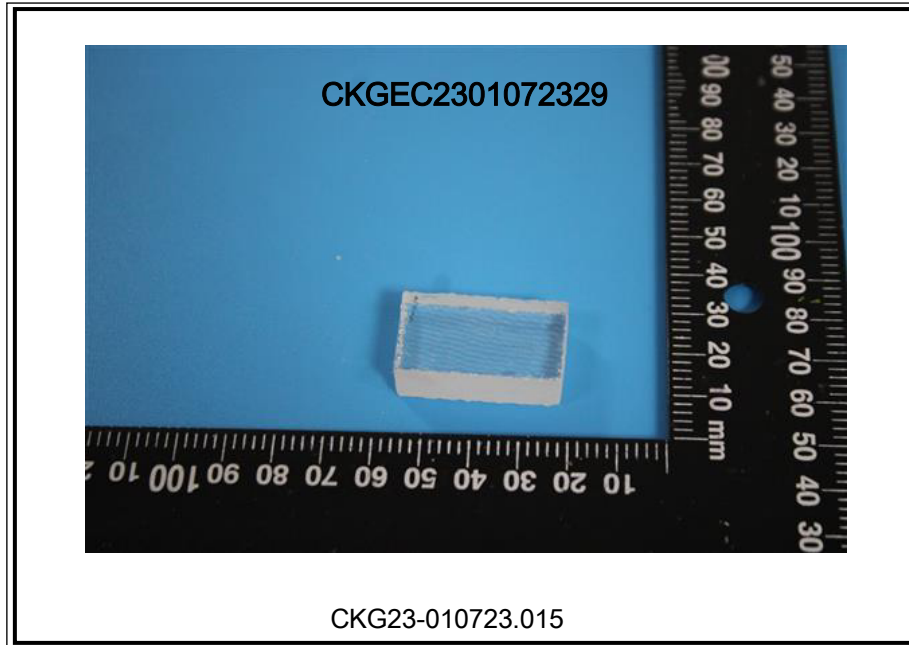
Sample photo:

Specimen No.	SGS Sample ID	Description
SN1	CKG23-010723.015	Colorless transparent glass
