Test Report

No.: CKGEC24000039803

Sample Name: Optic glass

Model No.: H-ZPK1A

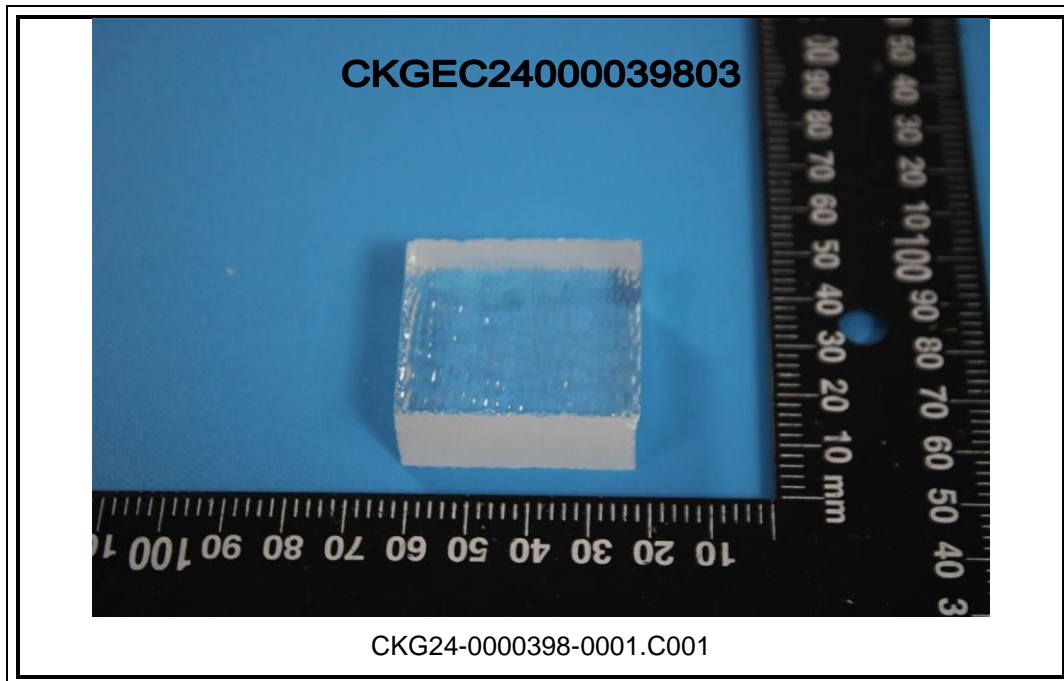
Sample Photo:

SN ID	Sample No.	SGS Sample ID	Description
SN1	A1	CKG24-0000398-0001.C001	Colorless semi transparent glass
