Test Report

No. CKGEC2301072337

Sample Name : Optic glass

Model No. : H-BAK6

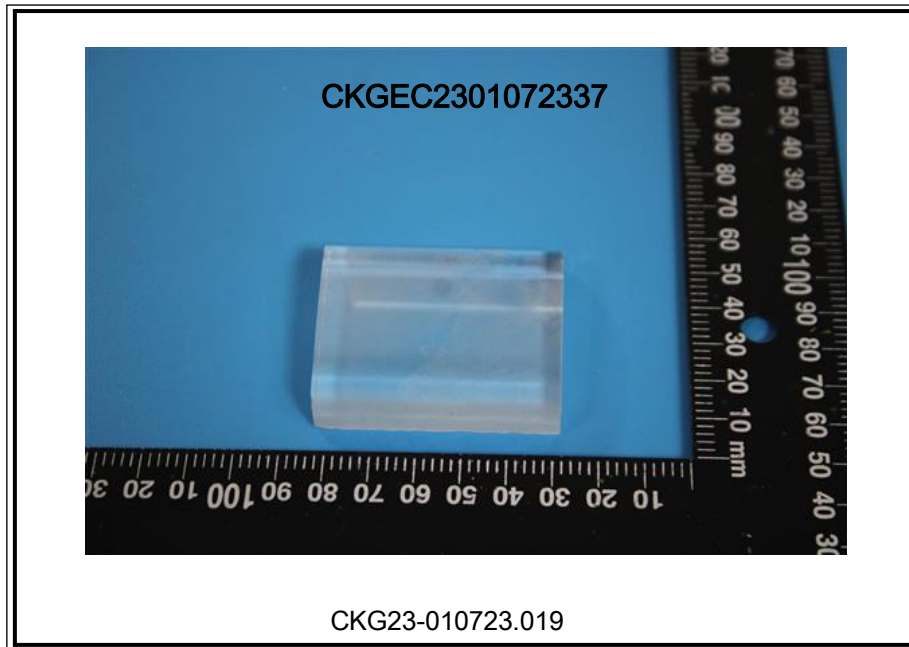
Sample photo:

Specimen No.	SGS Sample ID	Description
SN1	CKG23-010723.019	Colorless transparent glass
