Test Report

No. CKGEC2300888935

Sample Name : Optic glass

Model No. : D-FK61

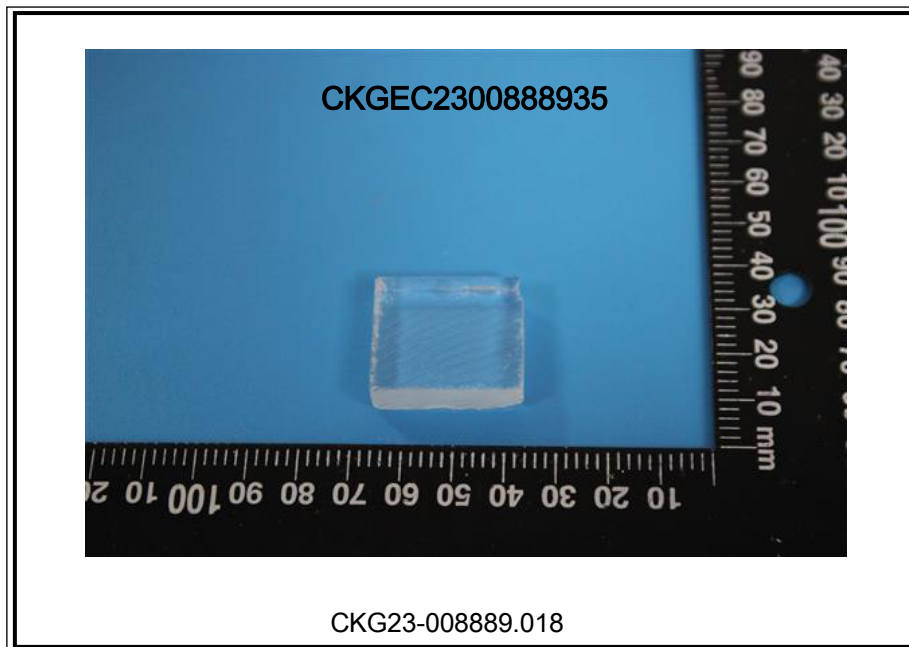
Sample photo:

Specimen No.	SGS Sample ID	Description
SN1	CKG23-008889.018	Colorless transparent glass
