Test Report

No. CKGEC2301072335

Sample Name : Optic glass

Model No. : H-BAK4

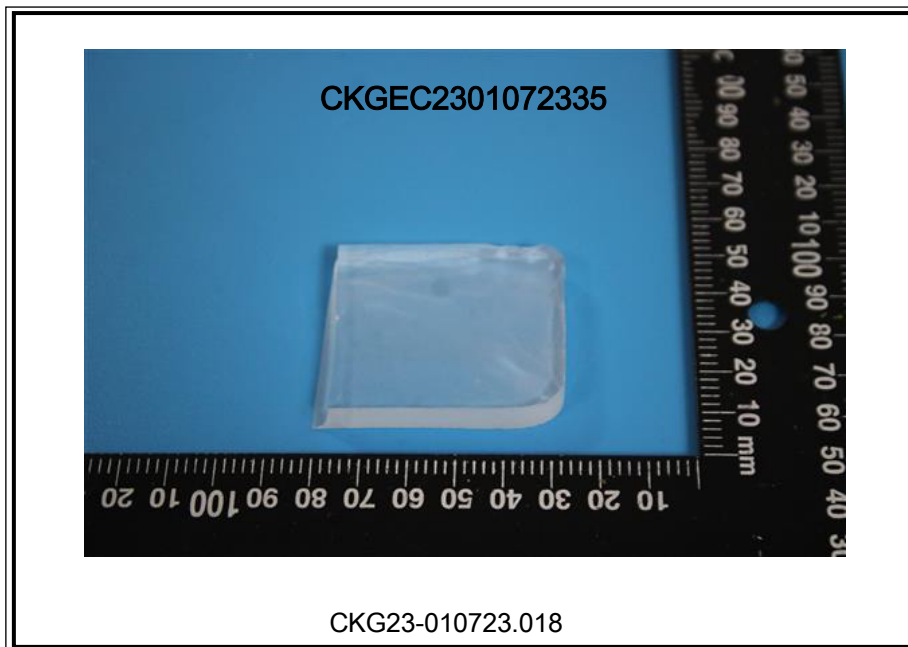
Sample photo:

Specimen No.	SGS Sample ID	Description
SN1	CKG23-010723.018	Colorless transparent glass
