## Test Report

No. CKGEC2300888929

Sample Name : Optic glass

Model No. : H-ZLAF75B

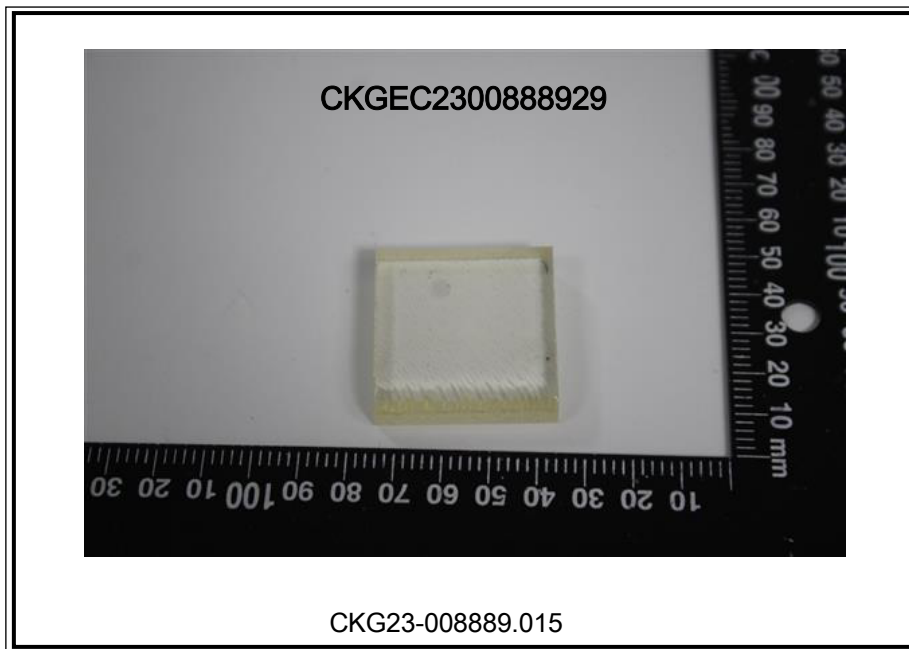
Sample photo:

Specimen No.	SGS Sample ID	Description
SN1	CKG23-008889.015	Light yellow glass
