Test Report

No. CKGEC2301072757

Sample Name : Optic glass

Model No. : H-QF50A

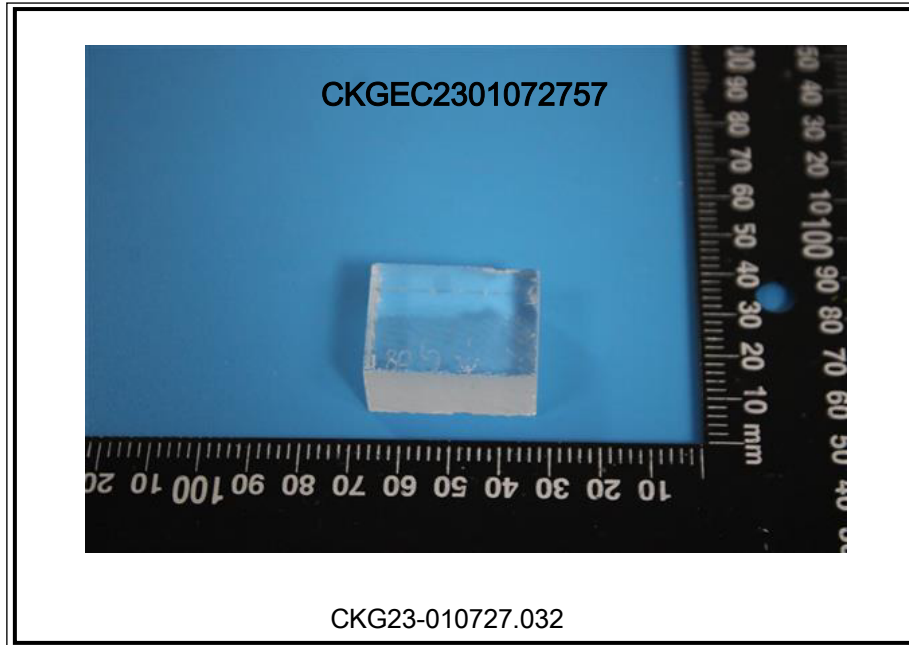
Sample photo:

Specimen No.	SGS Sample ID	Description
SN1	CKG23-010727.032	Colorless transparent glass
