## Test Report

No.: CKGEC24000037915

Sample Name: Optic glass

Model No.: H-ZK6

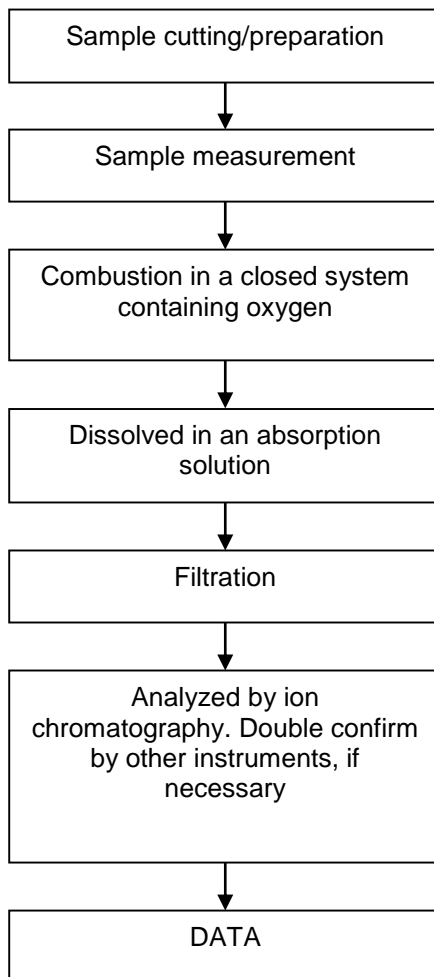
### Halogen Testing Flow Chart

Test Method: With reference to EN 14582:2016, analysis was performed by IC.

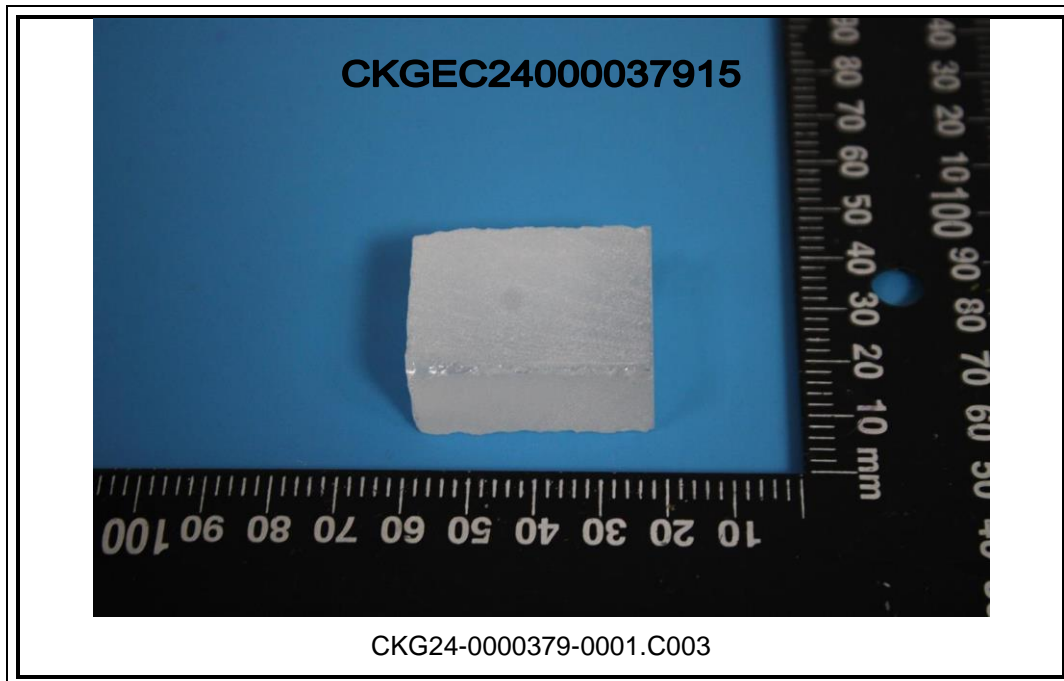
Sample Photo:

SN ID	Sample No.	SGS Sample ID	Description
SN1	A3	CKG24-0000379-0001.C003	Colorless semi transparent glass
