## Test Report

No.: CKGEC24000040931

Sample Name: Optic glass

Model No.: H-ZF11

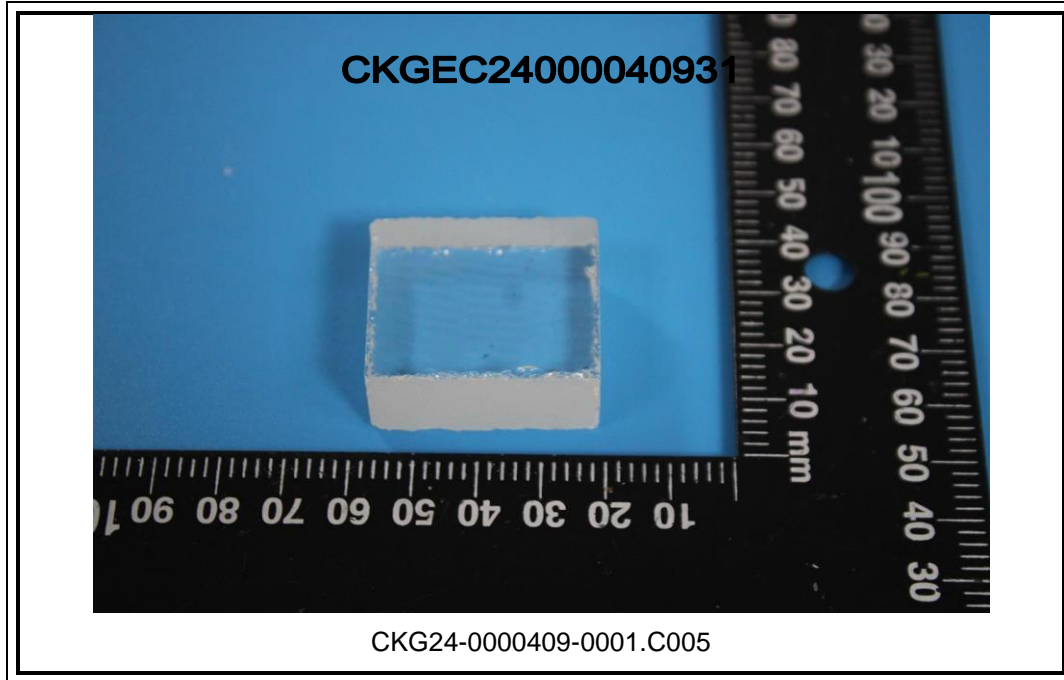
Sample Photo:

SN ID	Sample No.	SGS Sample ID	Description
SN1	A5	CKG24-0000409-0001.C005	Colorless transparent glass
