Test Report

No. CKGEC2301072319

Sample Name : Optic glass

Model No. : D-K9

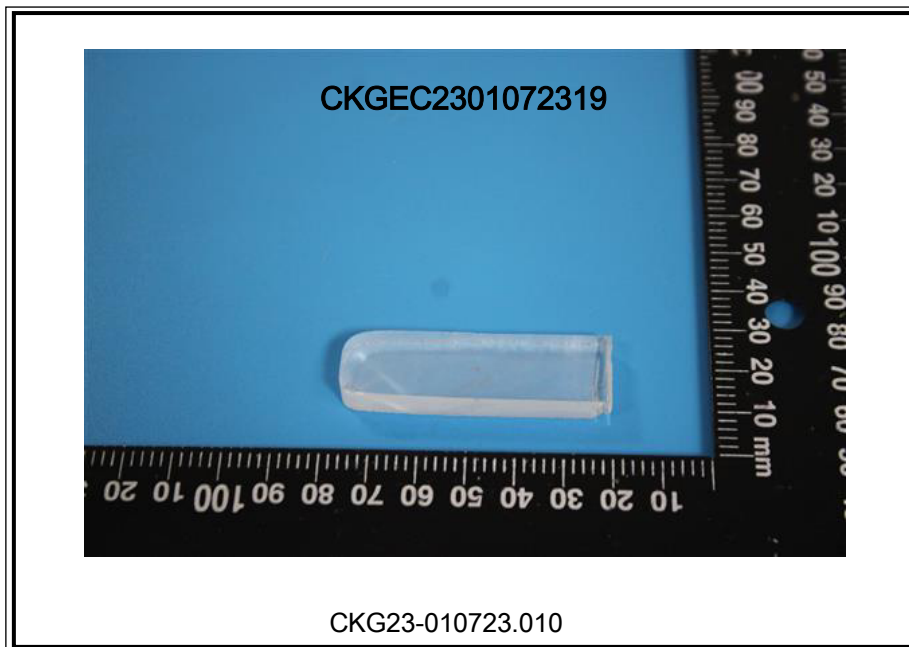
Sample photo:

Specimen No.	SGS Sample ID	Description
SN1	CKG23-010723.010	Colorless transparent glass
