Test Report

No. CKGEC2301072339

Sample Name : Optic glass

Model No. : H-BAK7

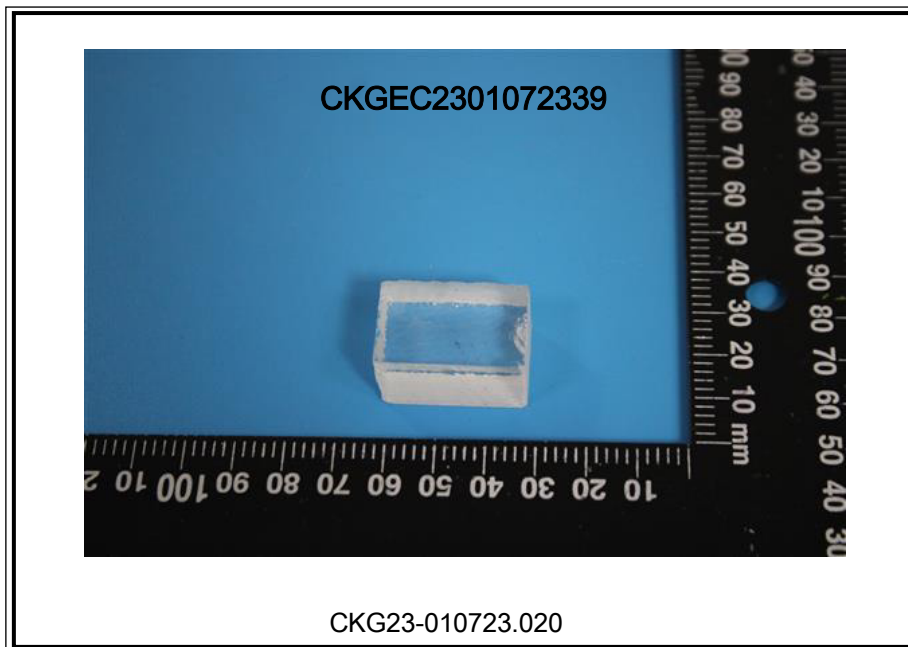
Sample photo:

Specimen No.	SGS Sample ID	Description
SN1	CKG23-010723.020	Colorless transparent glass
