Test Report

No. CKGEC2301072761

Sample Name : Optic glass

Model No. : H-ZF1A

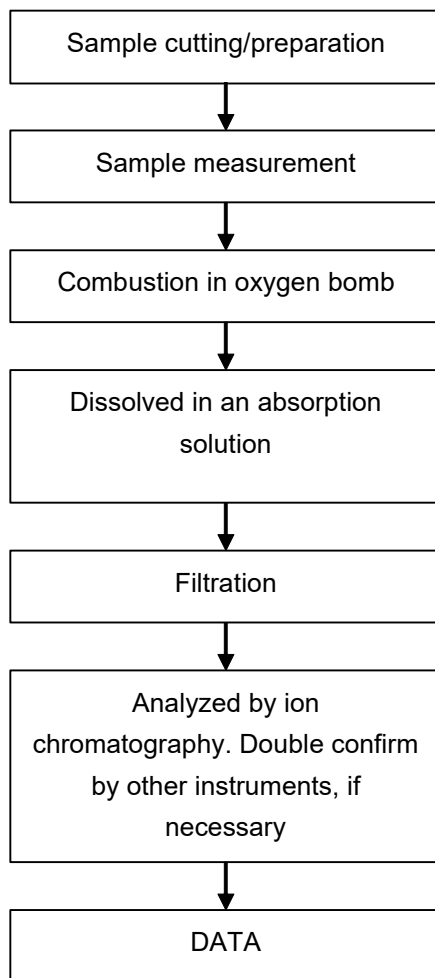
Halogen and Sulfur Testing (oxygen bomb) Flow Chart

Test Method : With reference to EN 14582: 2016, analysis was performed by Ion Chromatograph (IC).

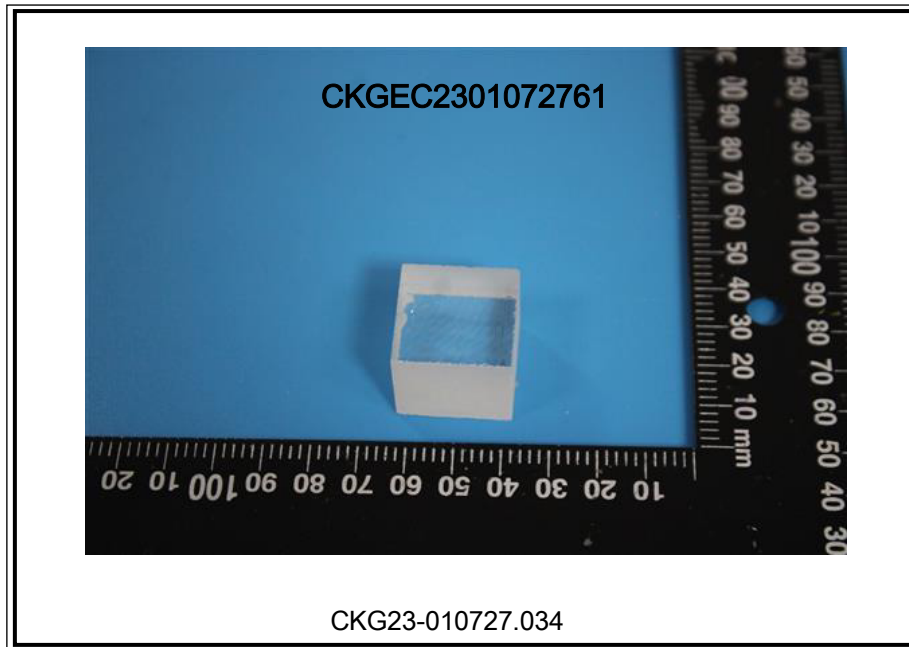
Sample photo:

Specimen No.	SGS Sample ID	Description
SN1	CKG23-010727.034	Colorless transparent glass
