Test Report

No. CKGEC2300888939

Sample Name : Optic glass

Model No. : D-ZF10L

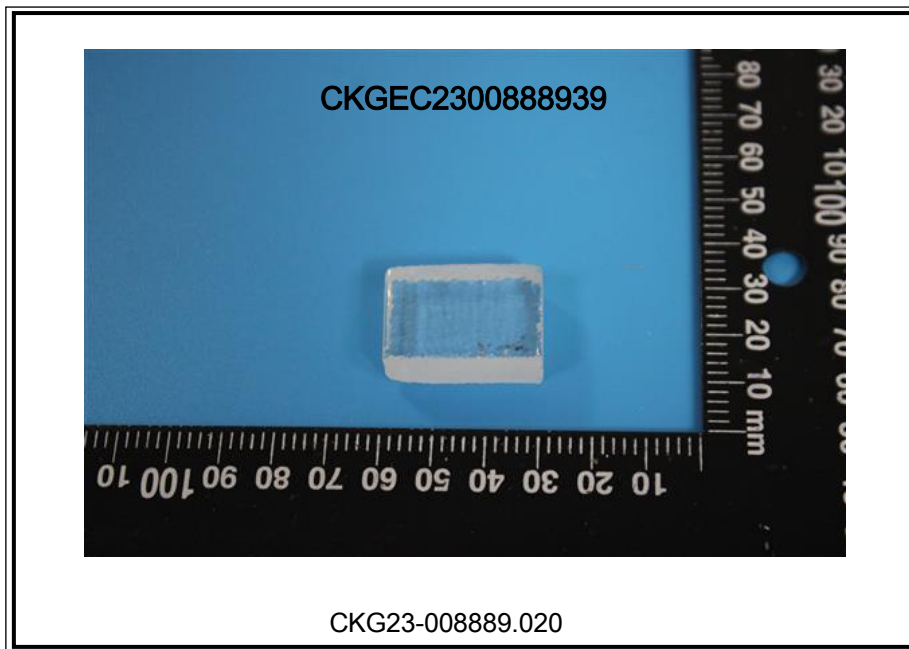
Sample photo:

Specimen No.	SGS Sample ID	Description
SN1	CKG23-008889.020	Colorless transparent glass
